PLUMBING DIAGRAMMS

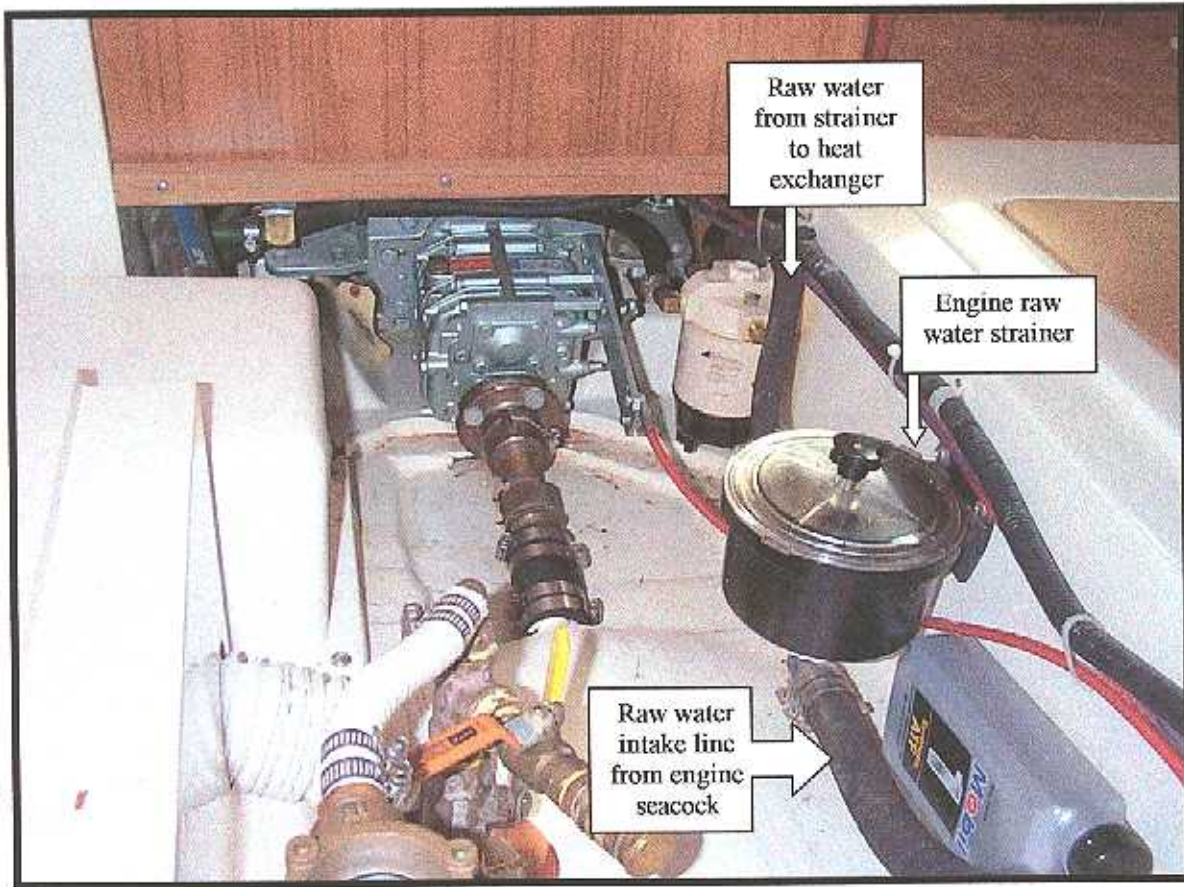
Figure 2.2 Raw water strainer. Aft Cabin - Picture taken from stern looking toward the engine

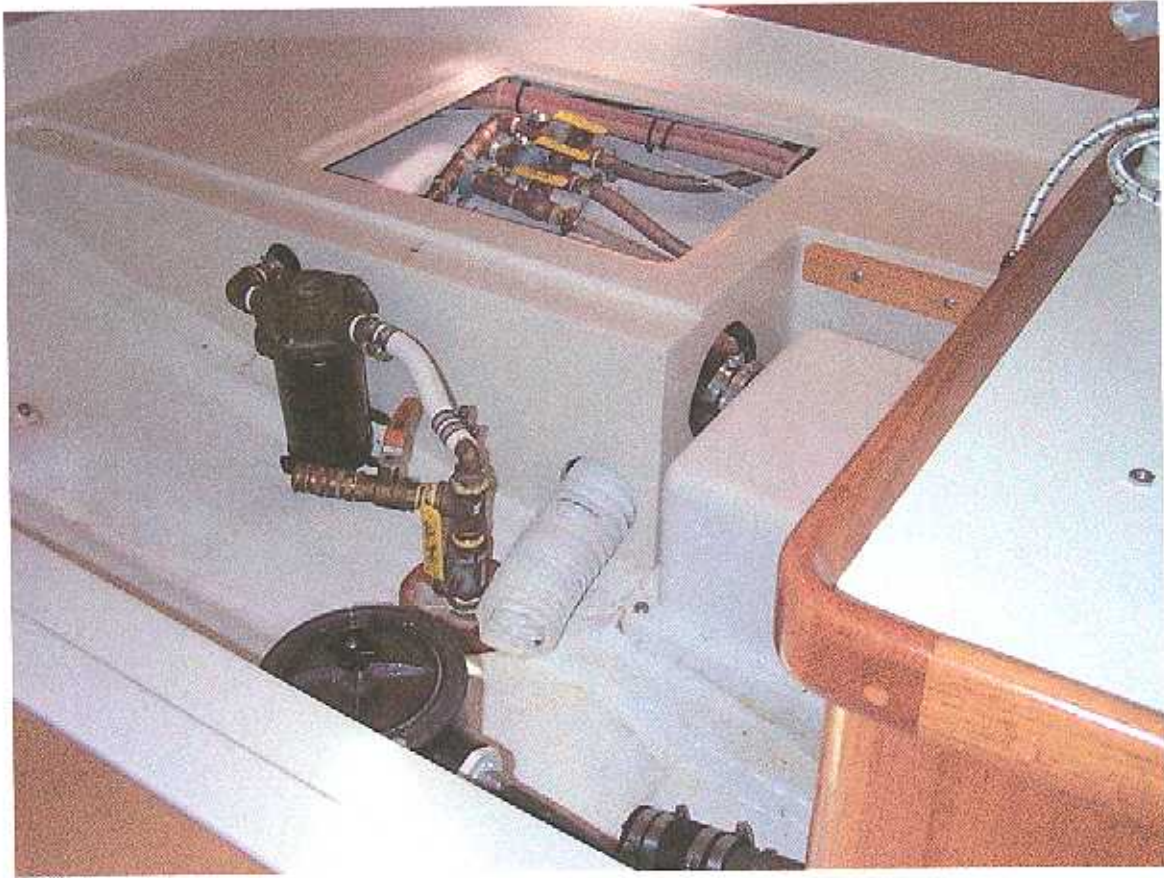
Fig 2.3 Accessory seawater seacock and manifold – general layout – Aft cabin looking toward the port quarter.

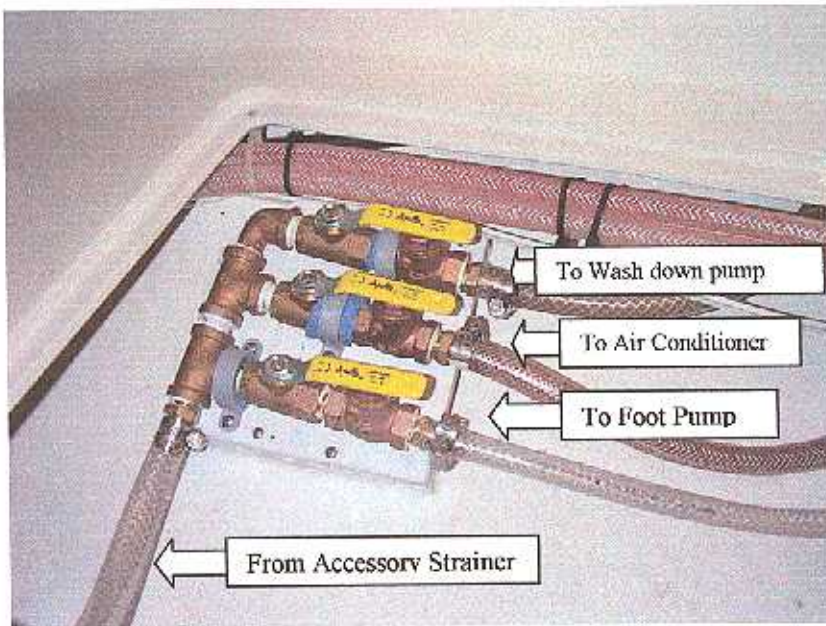
Fig 2.5 Accessory seawater manifold

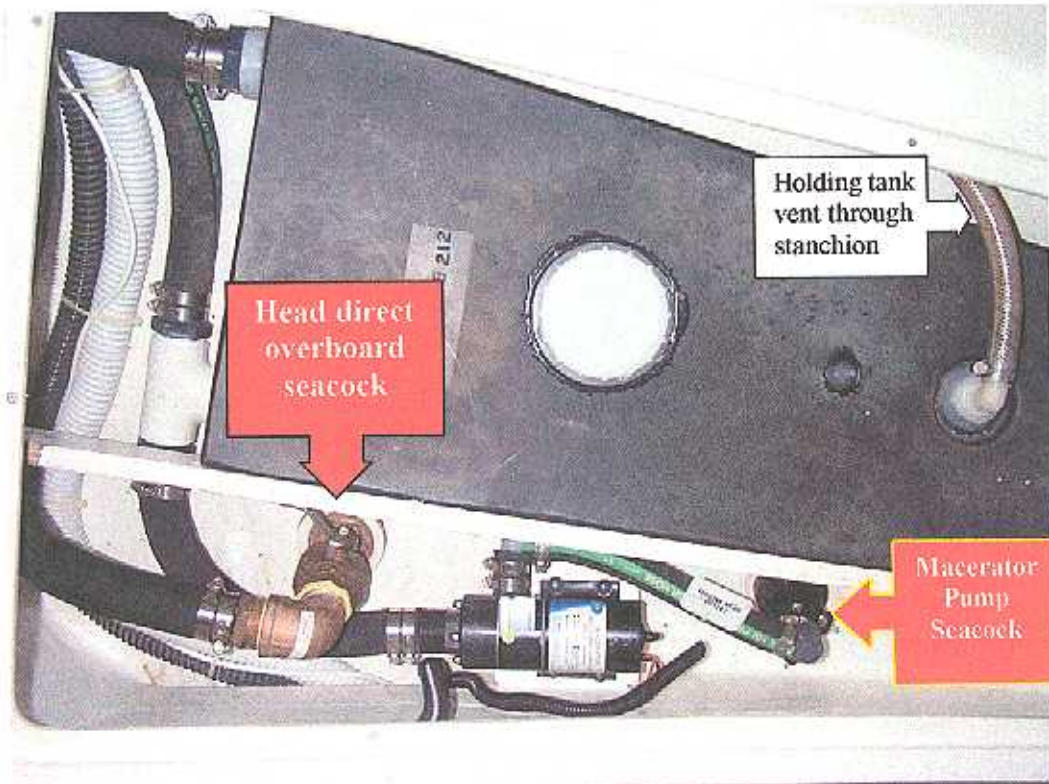
Figure 2.8 Holding tank, Head direct overboard discharge, Macerator pump and seacock.

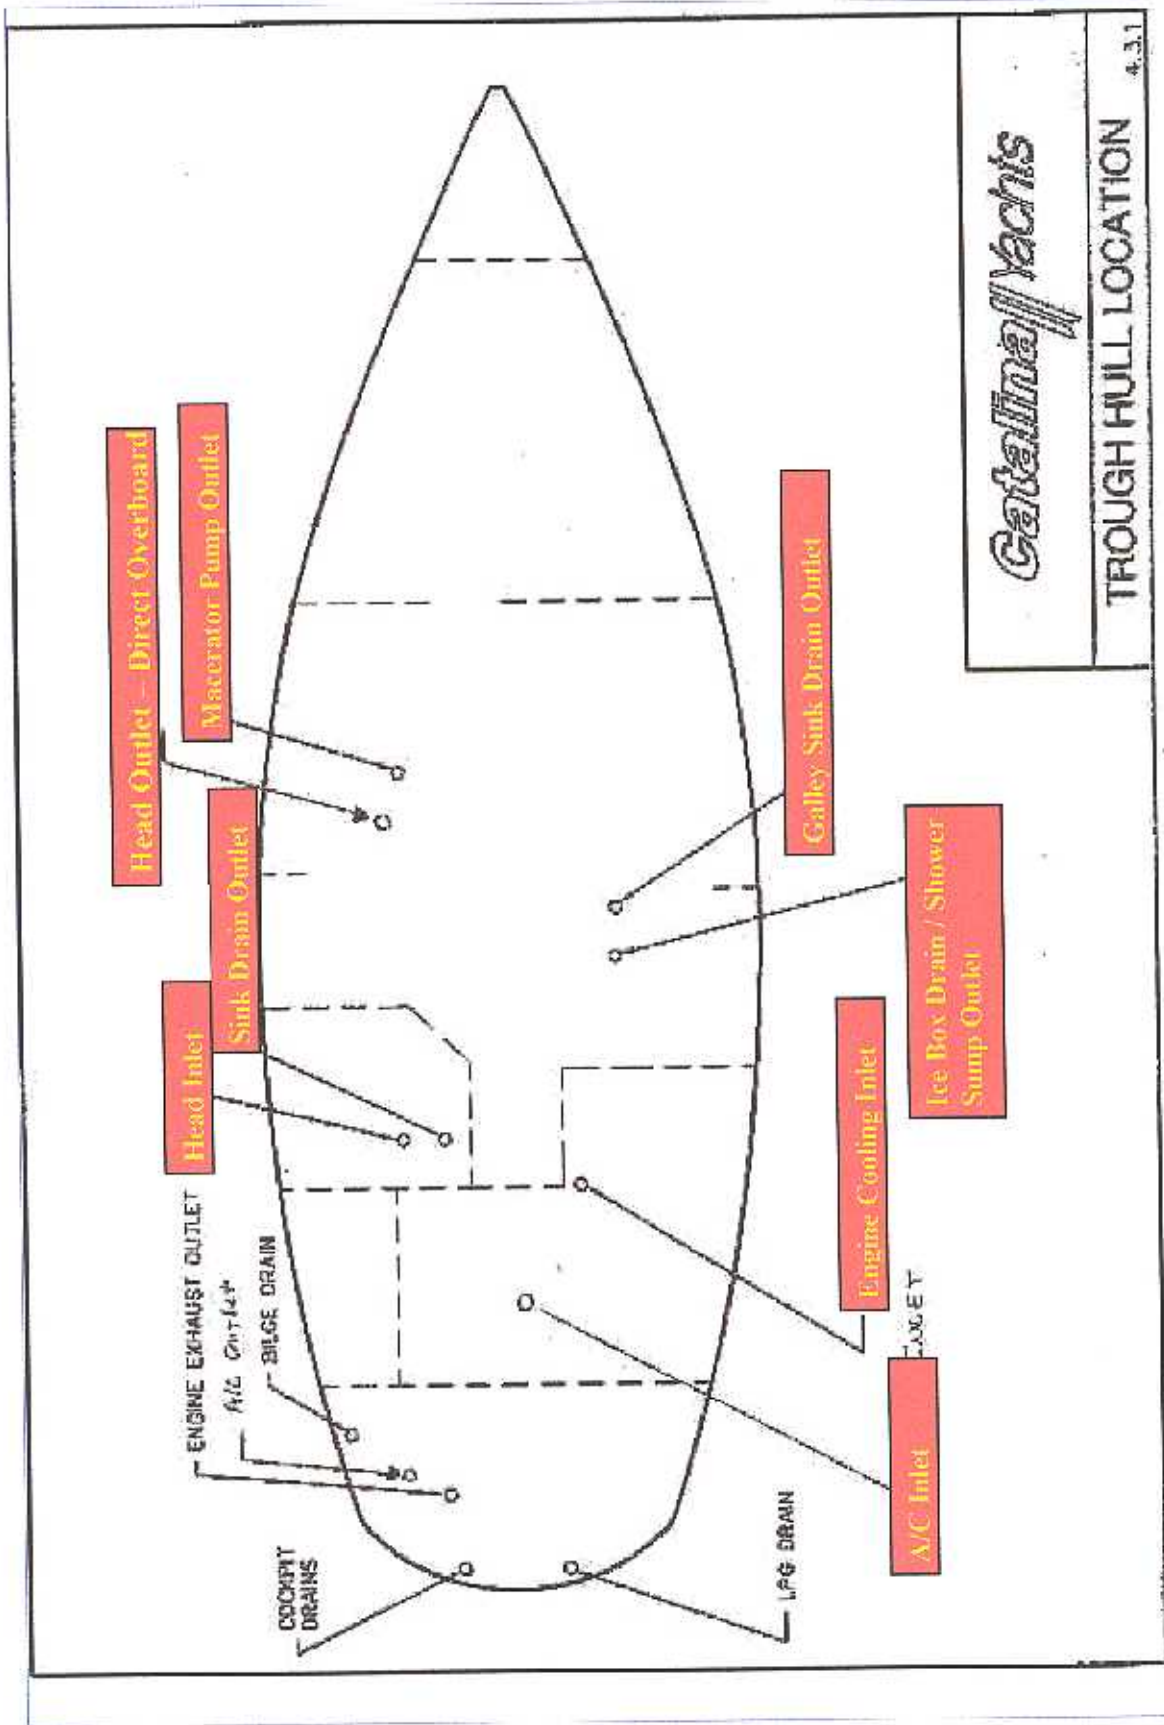
TROUGH HULL LOCATION 4.3.1
